RCRA Facility Assessment

Clayton Chemical Company

#1 Mobile Avenue

Sauget, Illinois

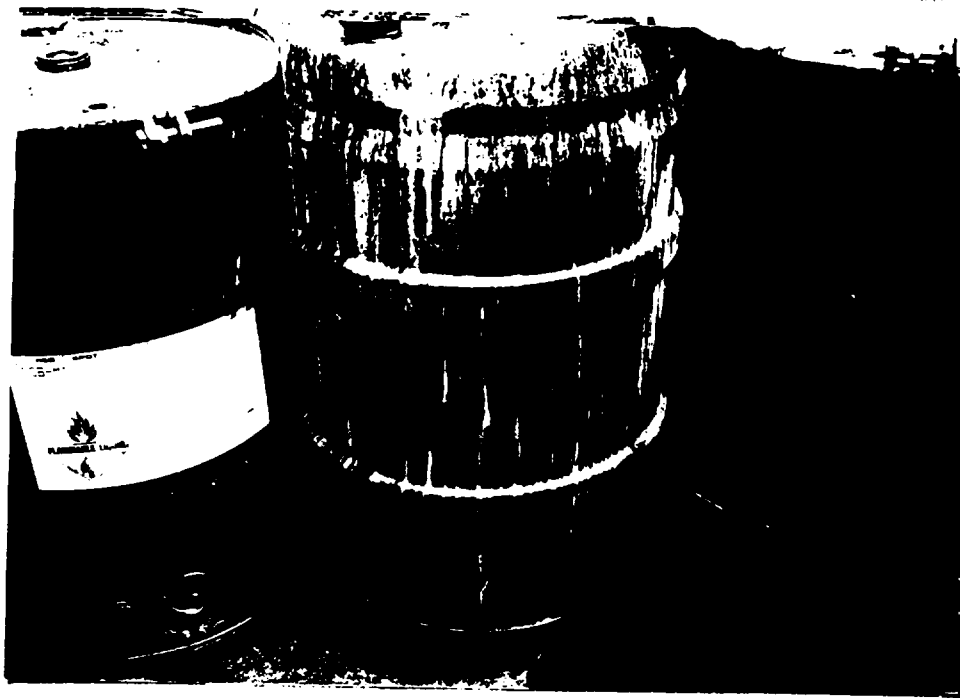
ROLL# 1079 PHOTO# 1

History of Releases: Stains and liquid have been observed on the dock in the past, however, no samples were taken to identify the material. Drums have been observed in questionable condition with spillage on the outside of the containers (tops and sides). Also, bulging drums have been observed. During a May 25, 1989 inspection, a violation Section 725.271 was alleged for a leaking drum which was observed. See Figure 5-3.

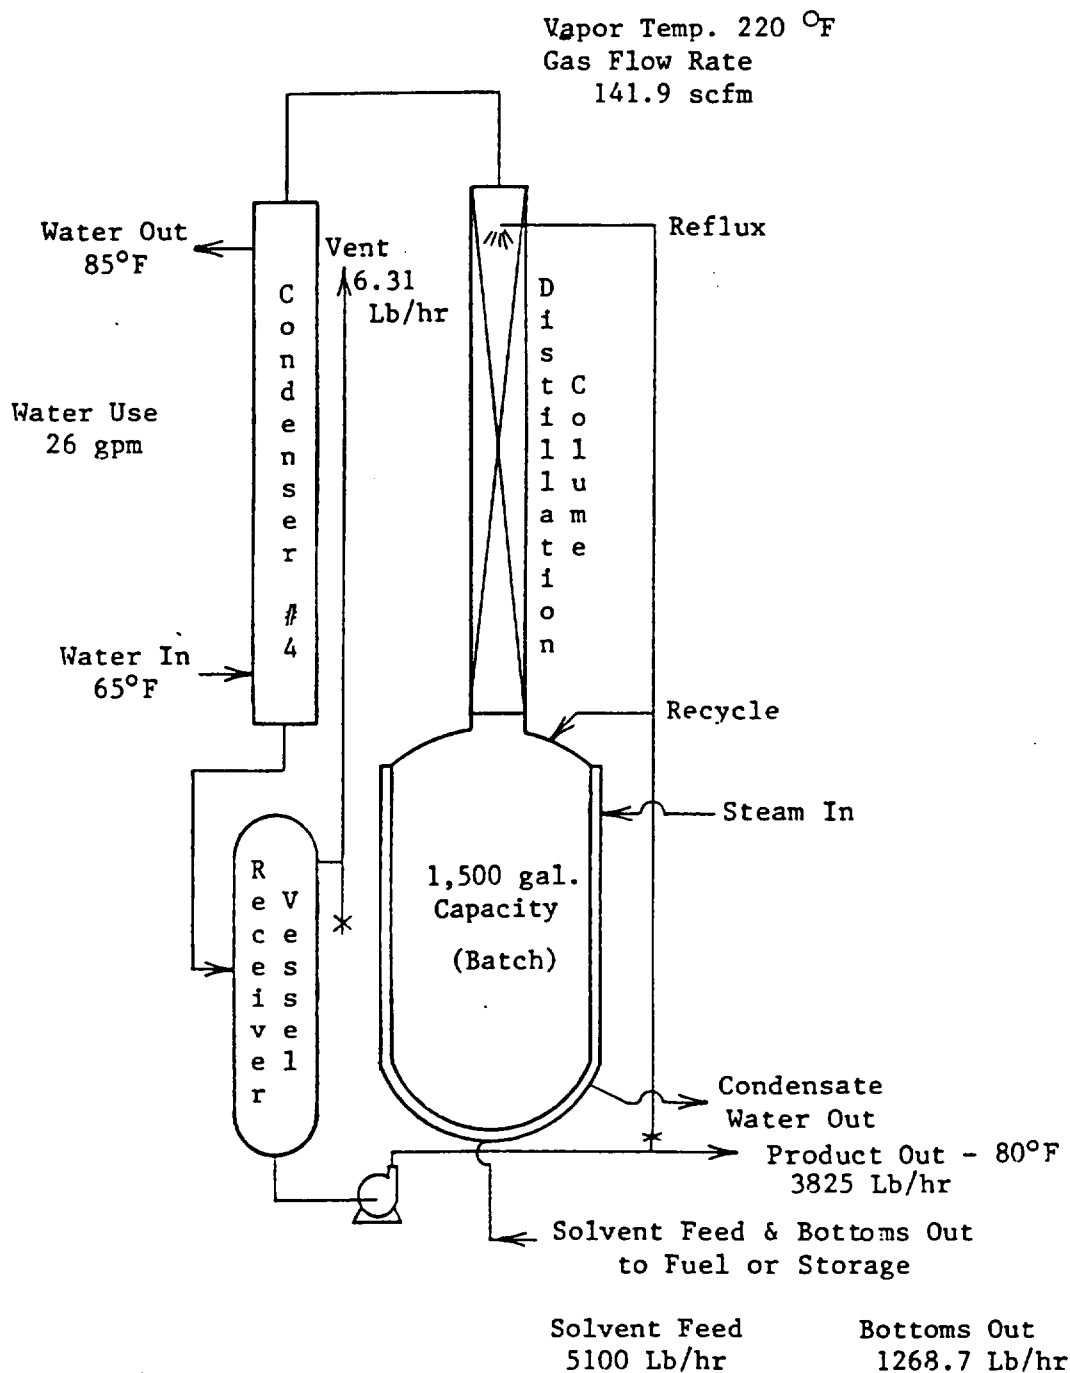
#4 "Frog" Distillation System

(Batch Processing)

SS tube condenser 322 sq.ft.

Average process rate 10 gal per min. (Flammable Solvent Blend)

Product to any clean solvent storage or other process system or transport tanker.

Bottoms to fuel or storage tank.

Operating pressure 0.5 psig.
